U. S. Bureau of Agricultural Engineering

Photo #4

Subject Damage by tornado about 5:00 p.m.

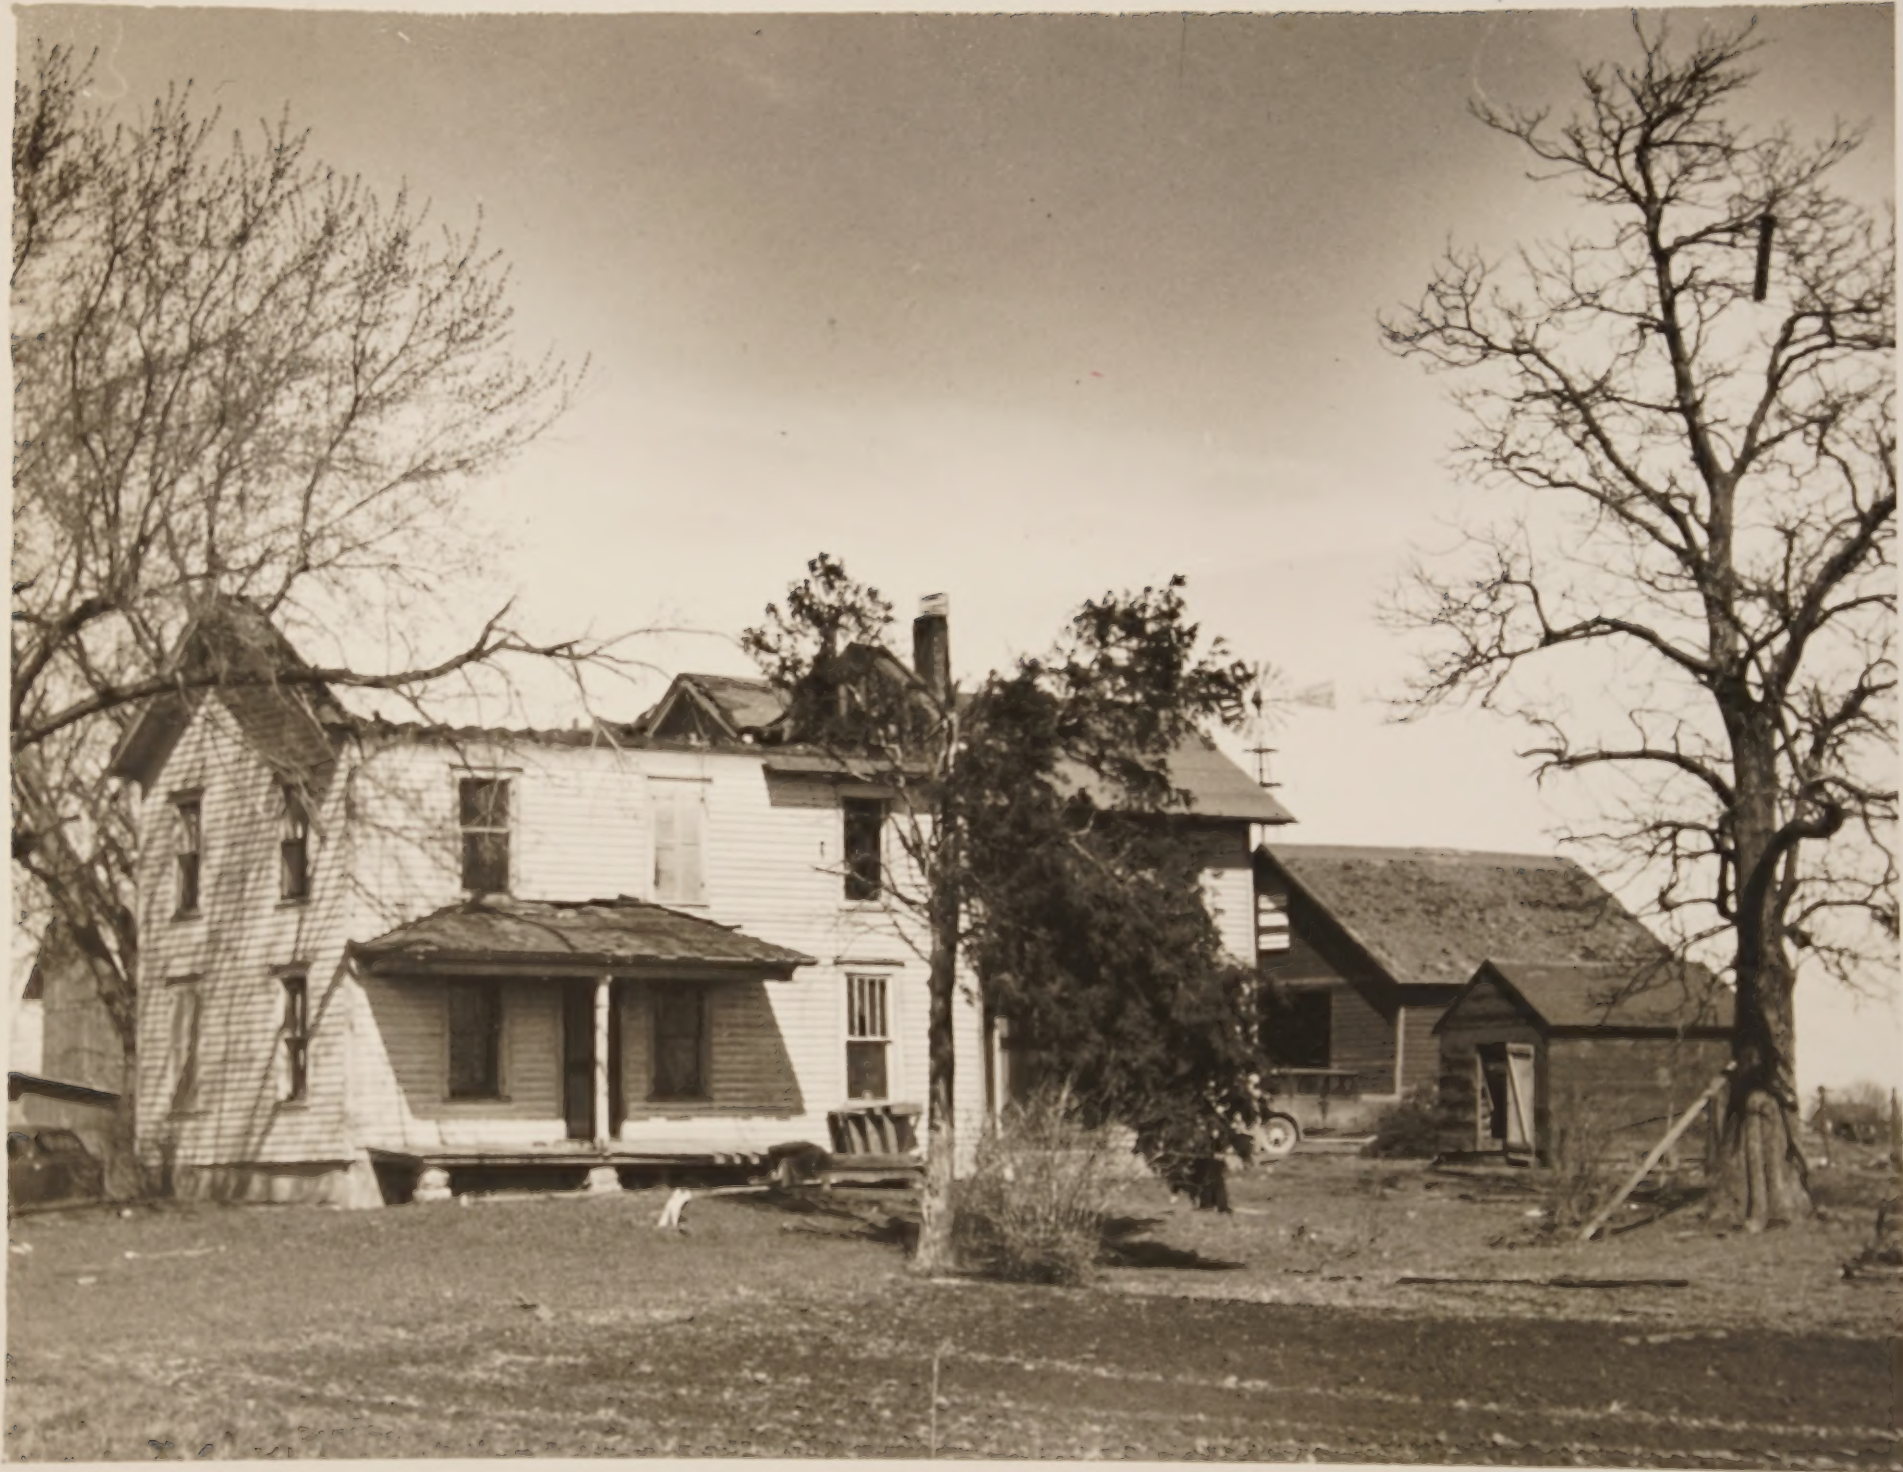
April 29. Note: Roof over 2 rooms torn

completely off. Porch columns and upper half  
of Cedar tree in foreground torn away.
